Hydromodification Assessment

Prepared for
Oak Lodge Sanitary District
June 2015

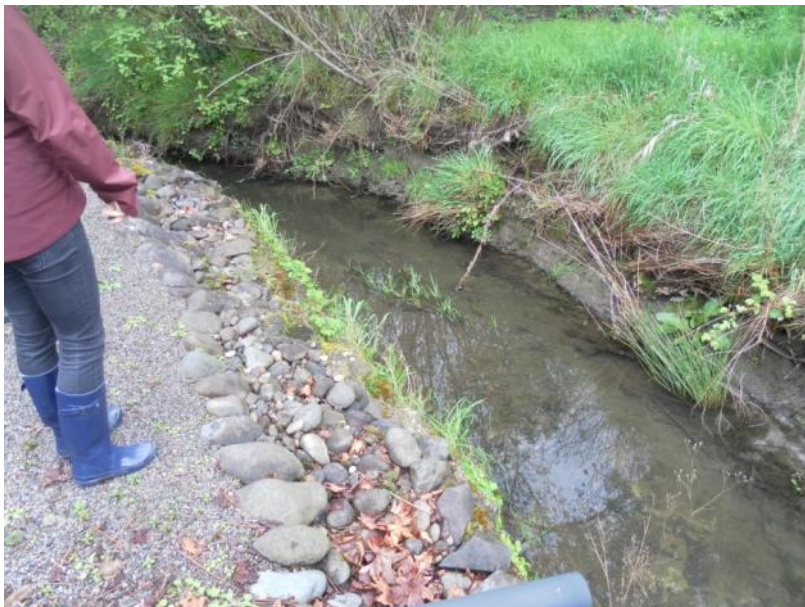
Site location: 002
Photo number: SAM_1201
Description: Private Property (15320 SE Laurie Ave). Channel reinforcement on inner bank.

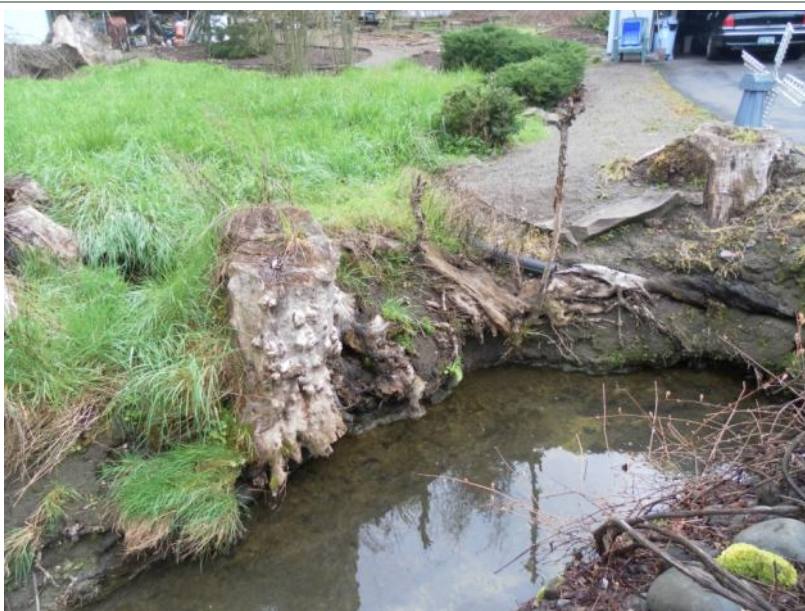
Site location: 002
Photo number: SAM_1202
Description: Private Property (15320 SE Laurie Ave). Exposed roots on eroding bank

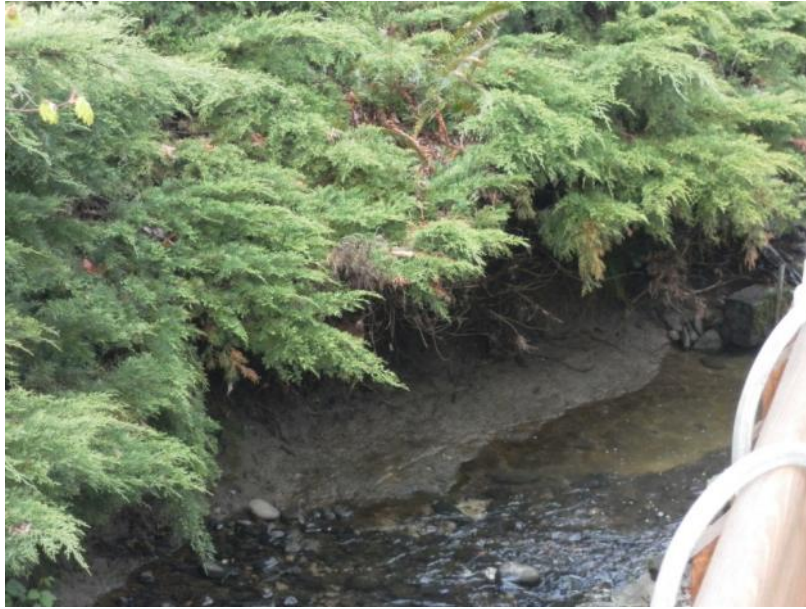
Site location: 004
Photo number: SAM_1208
Description: Private Property (15320 SE Laurie Ave). Exposed roots on eroding bank

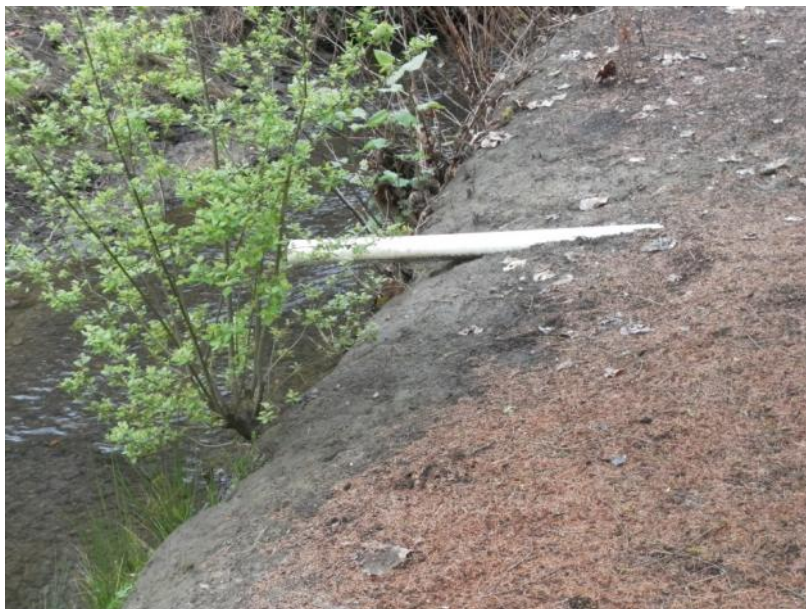
Site location: 002
Photo number: SAM_1209
Description: Private Property (15320 SE Laurie Ave). Area drain showing extent of channel widening (1 foot+ over 1 year)

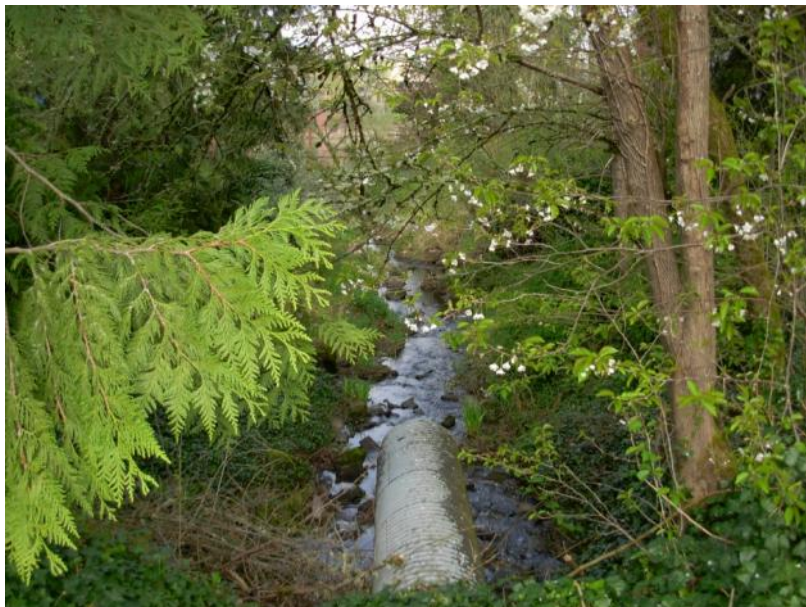
Site location: 008
Photo number: 012
Description: Perched culvert from River Forest Lake (under SE River Forest Dr.) to Willamette River

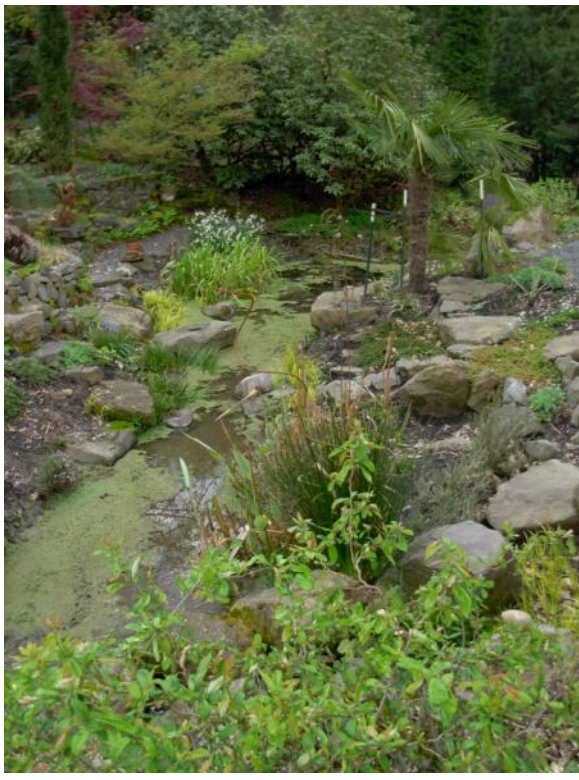
<p>Site location: 011 Photo number: 024 Description: Private Property (SE Linden Ave) - Stepped pools along backyard.</p>

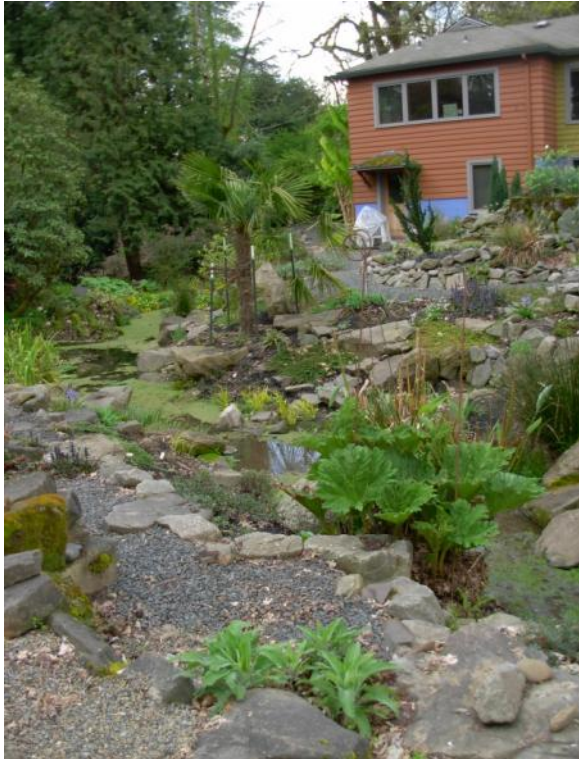
<p>Site location: 011 Photo number: 025 Description: Private Property (SE Linden Ave) - Stepped pools along backyard.</p>

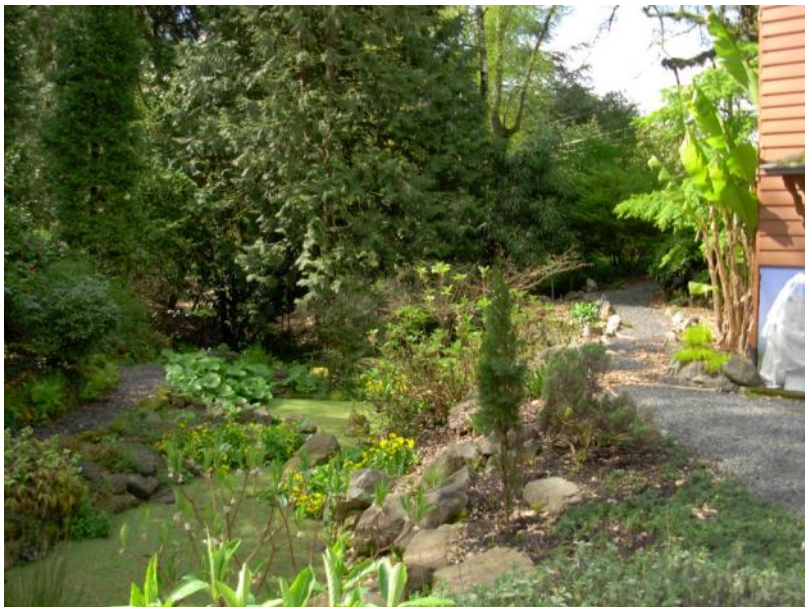
Site location: 011
Photo number: 027
Description: Private Property (SE Linden Ave) – Stepped pools along backyard.

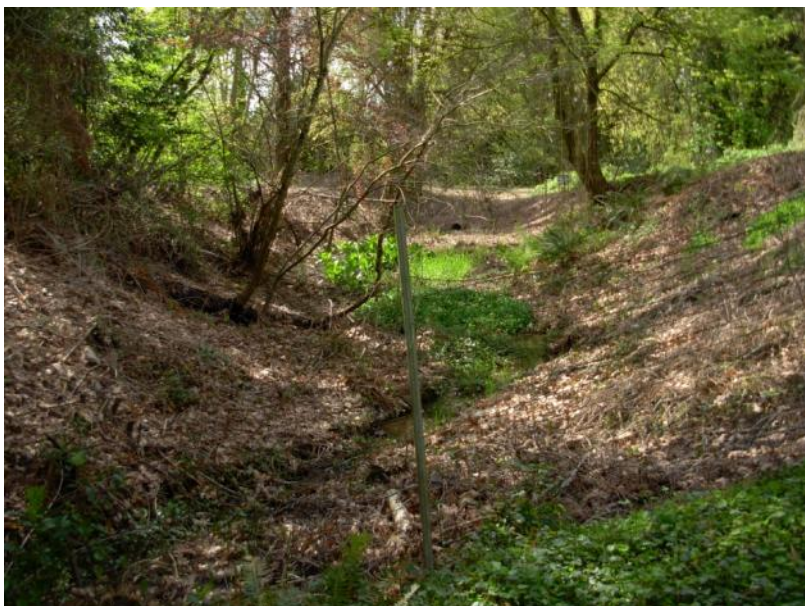
Site location: 011
Photo number: 028
Description: Widened channel downstream of SE Linden Ave. Discharge to culvert under SE Linden Avenue.

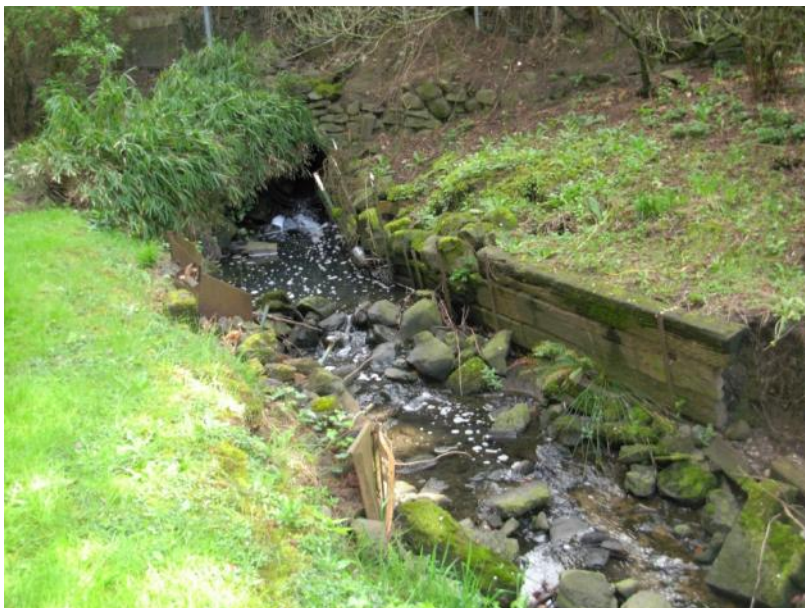
Site location: 012
Photo number: 032
Description: Private Property (3320 West View Ave). Reflects limited daylighted channel in backyard.

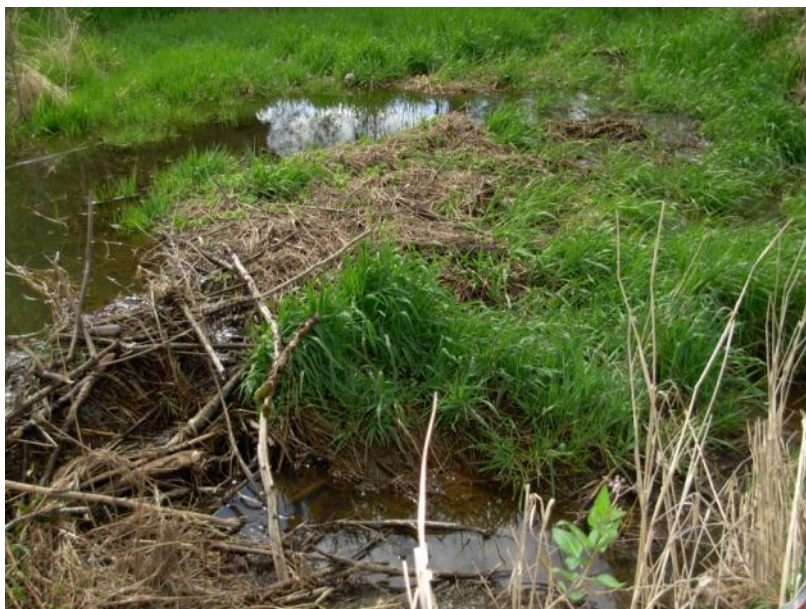
Site location: 014
Photo number: 042
Description: Beaver dam at outlet from Boardman Creek Wetlands.

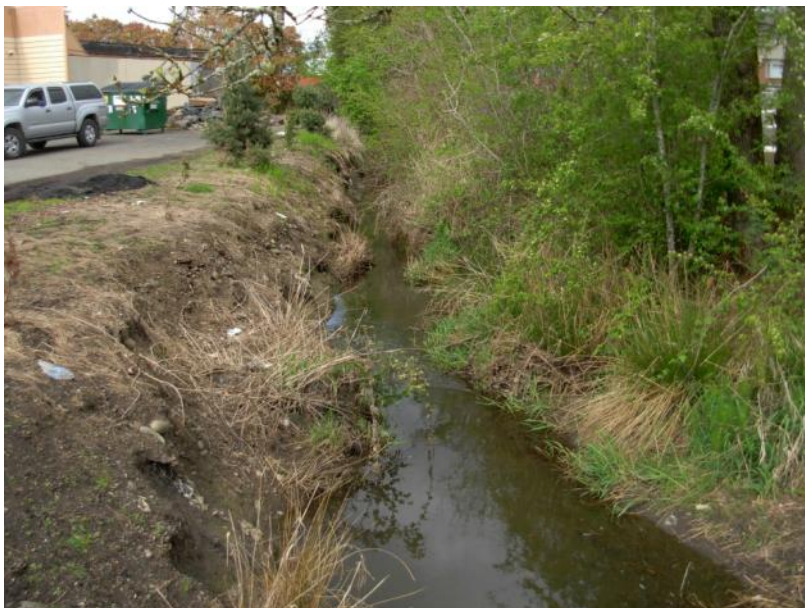
Site location: 015
Photo number: 044
Description: Incised channel and active eroding stream banks
