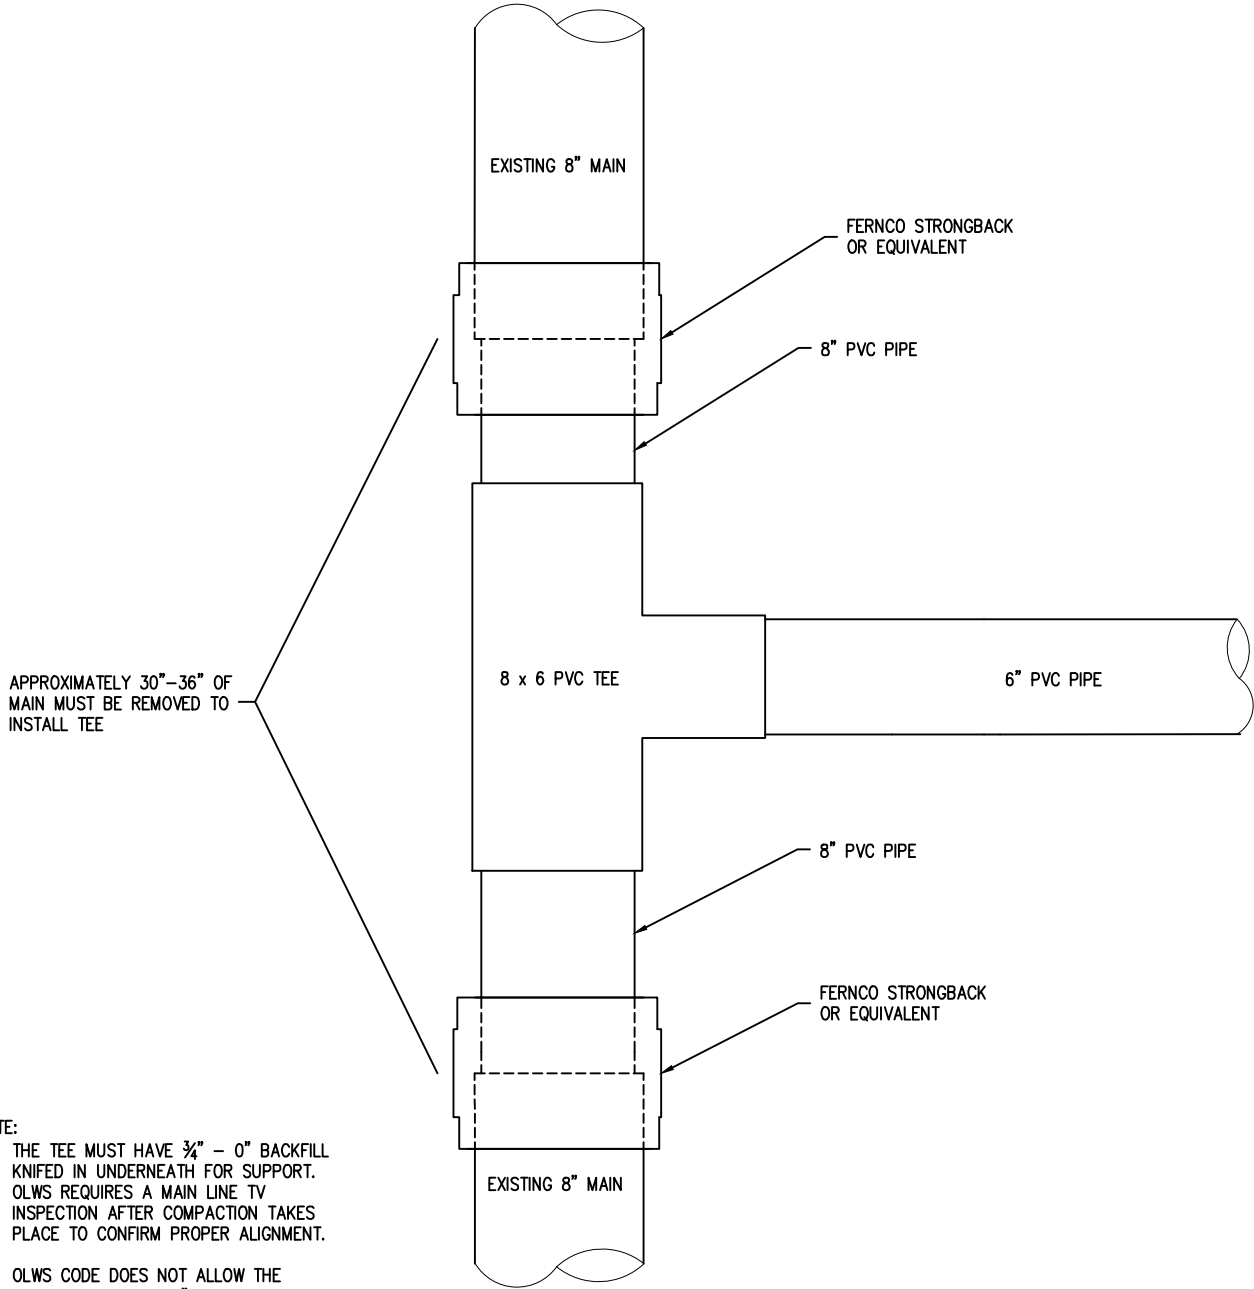
APPROXIMATELY 30"–36" OF MAIN MUST BE REMOVED TO INSTALL TEE

1. THE TEE MUST HAVE $\frac{3}{4}$ " – 0" BACKFILL KNIFED IN UNDERNEATH FOR SUPPORT. OLWS REQUIRES A MAIN LINE TV INSPECTION AFTER COMPACTION TAKES PLACE TO CONFIRM PROPER ALIGNMENT.
2. OLWS CODE DOES NOT ALLOW THE INSTALLATION OF A 6" INSERTA TEE ON AN 8" MAIN LINE AS IT WEAKENS THE STRUCTURAL INTEGRITY OF THE MAIN LINE. INSTEAD, A SECTION OF MAINLINE MUST BE REMOVED AND AN 8"x 6" PVC TEE SPLICED IN TO PROVIDE THE NEW TAP. NOTE THAT THIS OPERATION WILL REQUIRE THE SUBMISSION OF A WRITTEN "PUMP AROUND PLAN" FOR OLWS REVIEW.
